THE ROLE OF TWIN BOUNDARY AND ALPHA PRIME MARTENSITE
IN CORROSION FATIGUE OF AISI 304 STAINLESS STEEL

BY
SHUCHUN CHEN

A THESIS
PRESENTED TO THE GRADUATE COMMITTEE
OF LEHIGH UNIVERSITY
IN CANDIDACY FOR THE DEGREE OF
MASTER OF SCIENCE
IN
DEPARTMENT OF MATERIALS SCIENCE AND ENGINEERING

LEHIGH UNIVERSITY
FALL 1990

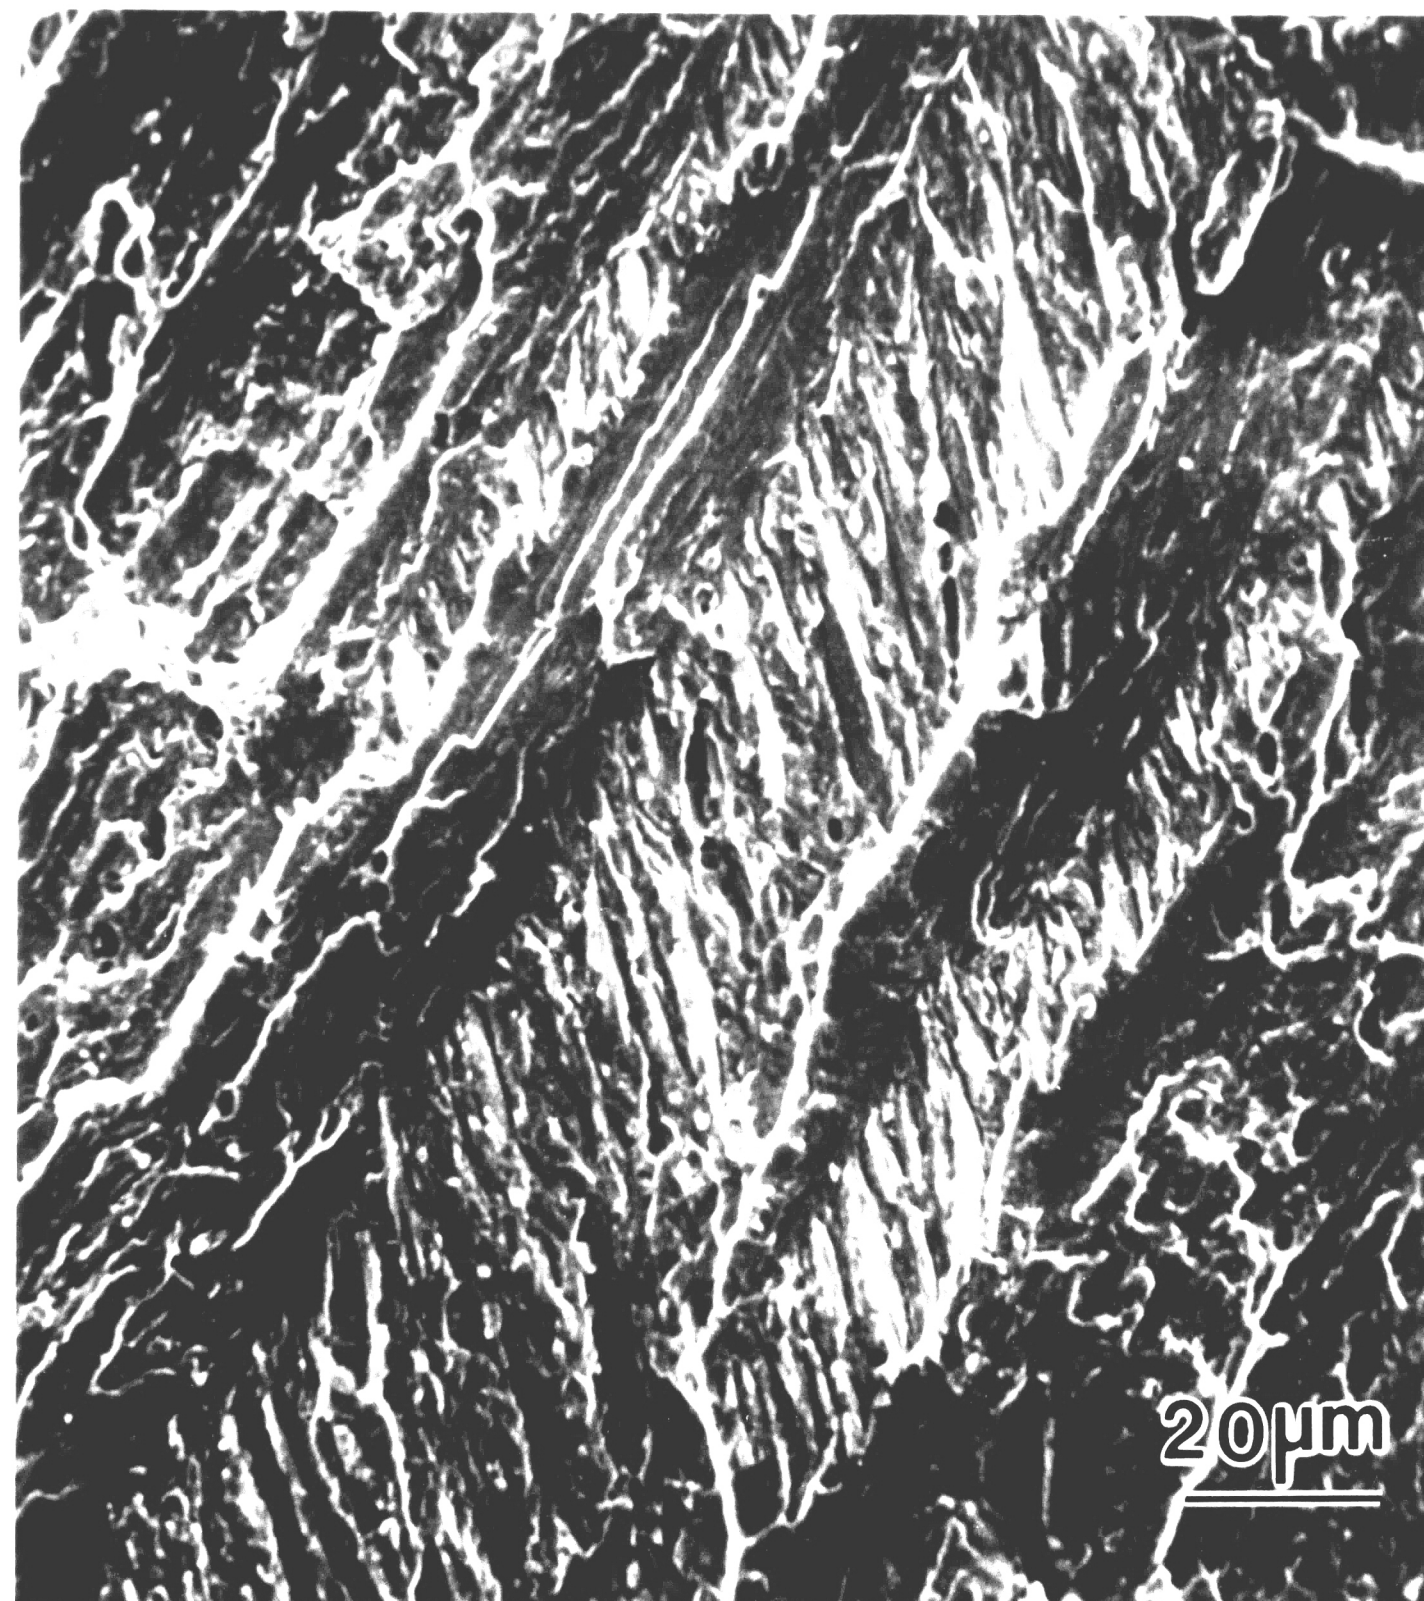
Fig. 17 SEM microfractographs of cold-rolled 304 stainless steel tested in 3.5% NaCl solution at $\Delta K=30 \text{ MPa}\sqrt{\text{m}}$, $R=0.1$, $f=10 \text{ Hz}$ and 298 K , showing parallel laths in the fracture surface.

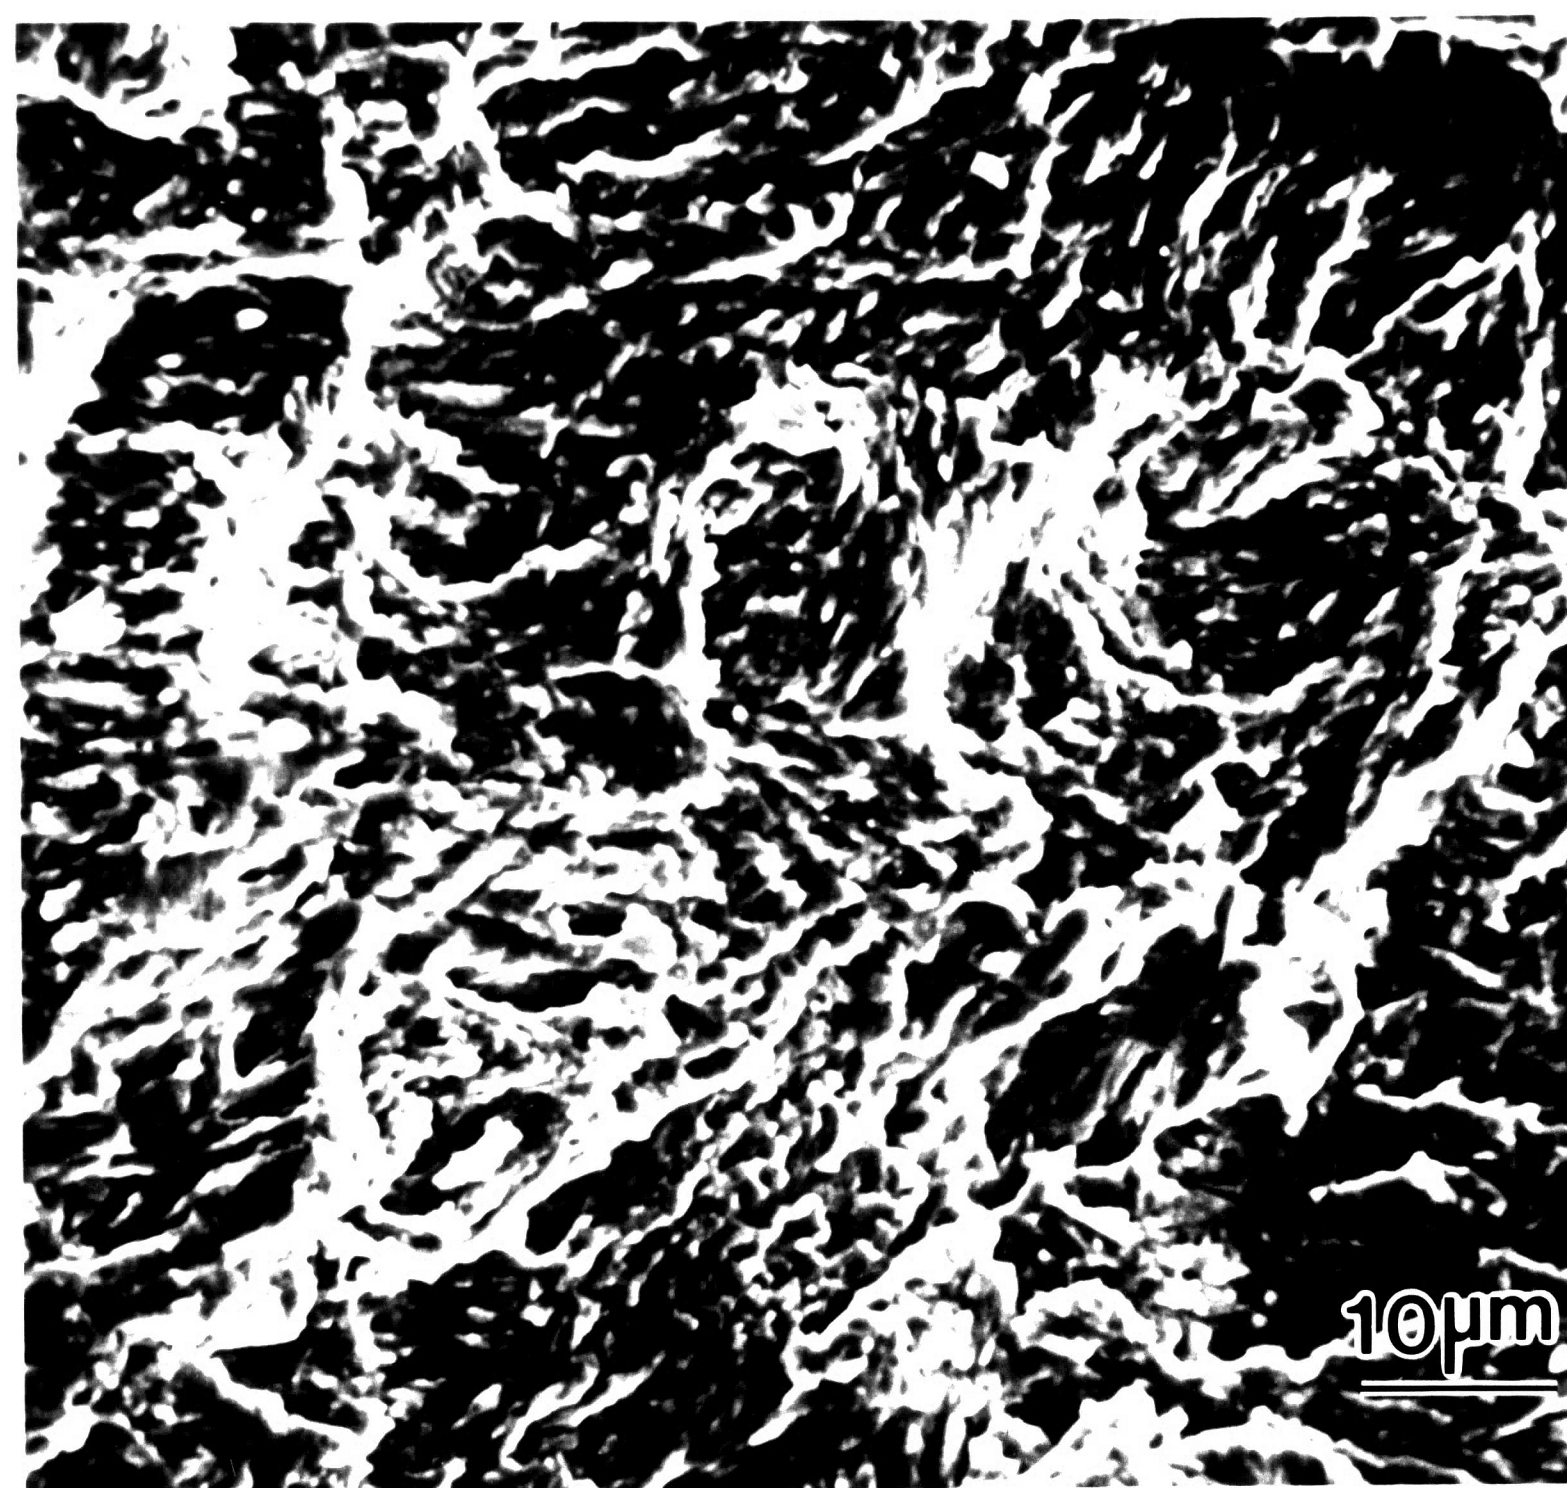
Fig. 20 SEM microfractograph of cold-rolled 304 stainless steel tested in vacuum showing ductile nature of the fracture surface morphology.
